# PRACTICE ALERT: MEDICAL IMAGING

## Risk of Masks Being MR Unsafe

Date: May 20, 2020

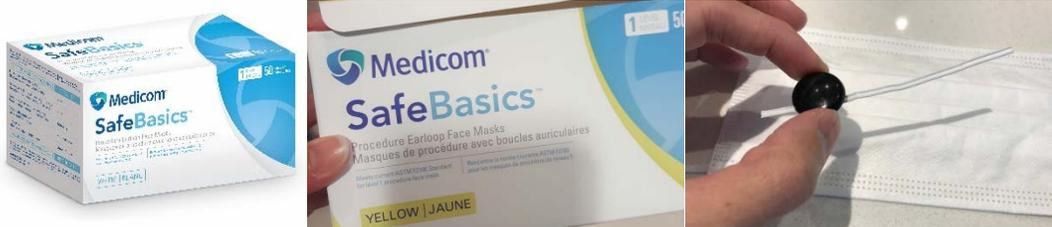
It was found that the nose bridge of some Medicom-branded procedure masks (comes in various colours) was ferromagnetic. If the mask is near the bore of the MRI scanner (1.5 and 3T), the nose piece may be attracted to the magnetic field. In these situations, there may be a gap between the mask and face.

The following Medicom masks, #2133 (Yellow-ASTM 1) and #2150 (White-ASTM 3), are ferromagnetic.

1. Remove Medicom SafeBasics #2133 (Yellow-ASTM1) and #2150 (White-ASTM3) masks immediately
2. All Medicom-branded procedure masks must be tested with a strong handheld magnet (>1000 gauss) prior to use in the MRI environment
3. If the nose bridge of the procedure mask is ferromagnetic, the product is removed immediately from the MRI department
4. The product is flagged and communicated to the MRI supervisor, Site Coordinator and MRI Regional Practice Lead
5. A product investigation should be submitted to PHSA by the Site Coordinator in collaboration with the MRI Regional Practice Lead
